STAFF REPORT

Project Title: Clark Historic District

DESIGN GUIDELINES FOR THE CLARK HISTORIC DISTRICT

Eureka, California

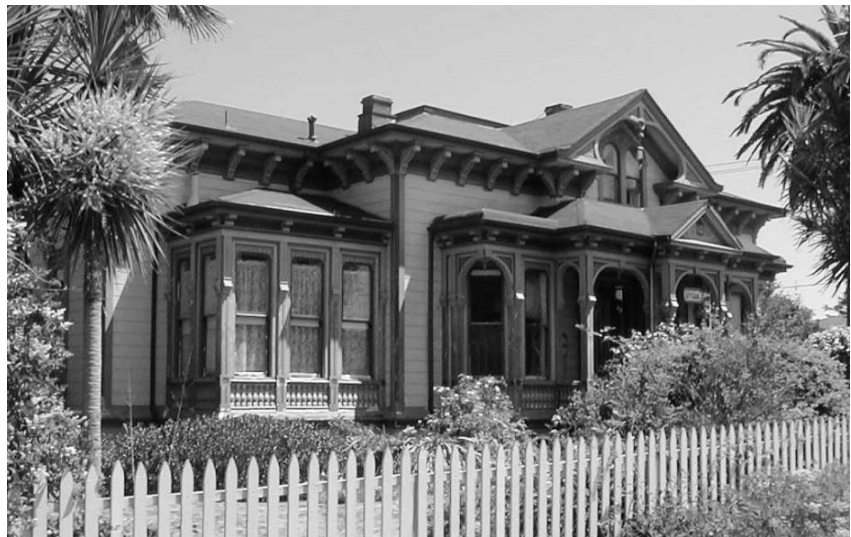
Italianate houses are another popular style in the 1870 to 1880 period. These houses drew on the rustic styles of Italian farmhouses, and were brought to the United States via the English picturesque movement. Italianate houses generally feature:

- Low pitched hipped roofs.
- Windows may be arched or rectangular with one over one or two over two sashes.
- Elaborate window trim or hoods
- Elaborate cornices, featuring brackets either singly or in pairs.

Thirteen Italianate houses have been identified in the Clark Historic District.

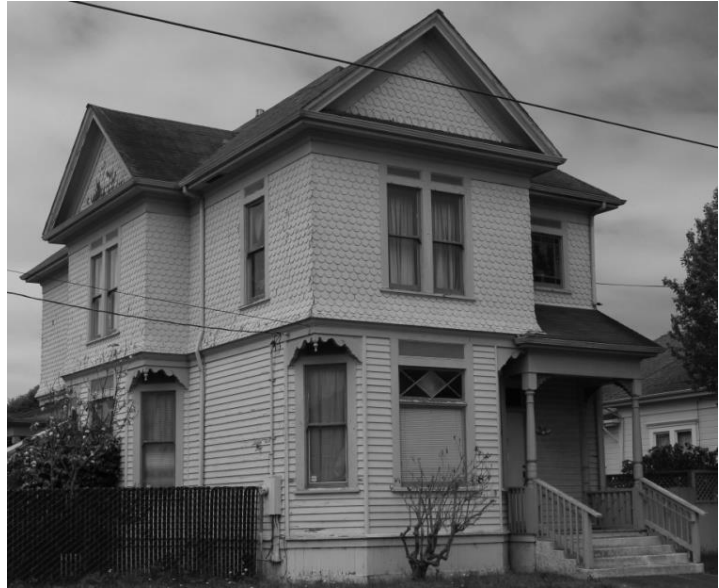
Stick/Eastlake style houses appeared in Eureka around 1890, and remained common until c. 1906. These houses emphasized straight, vertical lines and boxy forms. They typically have:

- Asymmetrical forms with low pitched hipped roofs
- One or two rectangular bays, usually set on the front façade, but sometimes at the building's corners
- Applied detail, or “stickwork” including a variety of trim boards and narrow brackets beneath the eaves
- Long and narrow windows and doors continuing the emphasis on vertical lines

Seven Stick/Eastlake houses have been identified in the Clark Historic District.

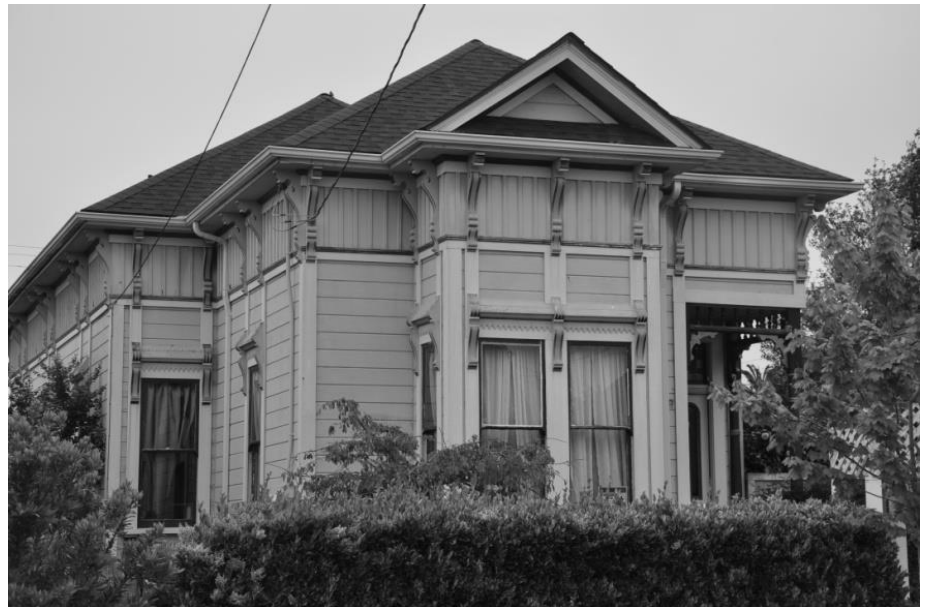
The Queen Anne style, a very popular style in Eureka from 1885 to 1900 and even to 1910, is characterized by:

- Irregular roof shapes and building masses
- Highly textured wall surfaces
- Cut away bays
- Scroll cut brackets
- Bargeboards
- Turned spindlework
- A variety of siding types, shingles, shiplap, etc.
- Overhanging upper stories
- Porches, with wrapping porches being the most common
- Classical columns
- Towers, turrets, oriel windows, chamfered corners
- Double hung windows

Thirty-eight Queen Anne houses have been identified in the Clark Historic District, making it the most frequently observed style in the area.

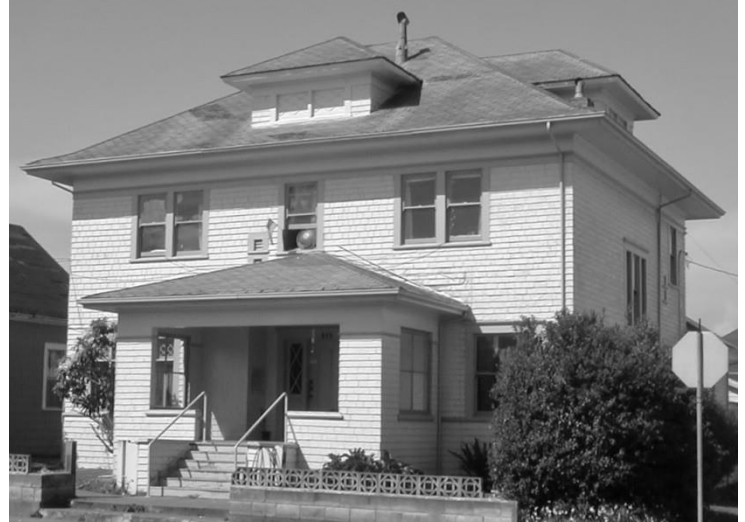
The Colonial Revival style was popular from about 1890 to 1915 and was influenced by Georgian and Dutch Colonial prototypes. Houses built in this style were large and could have:

- A symmetrical façade
- A low pitched hipped or side gabled roof
- A prominent portico
- Elaborate door surrounds including sidelights or fanlights
- Double hung windows in pairs with multiple panes in the upper or both sashes
- Prominent Palladian windows or windows with rounded arch heads
- Boxed cornice with little overhang and decorated with dentils or modillions,
- Open eaves and rakes.

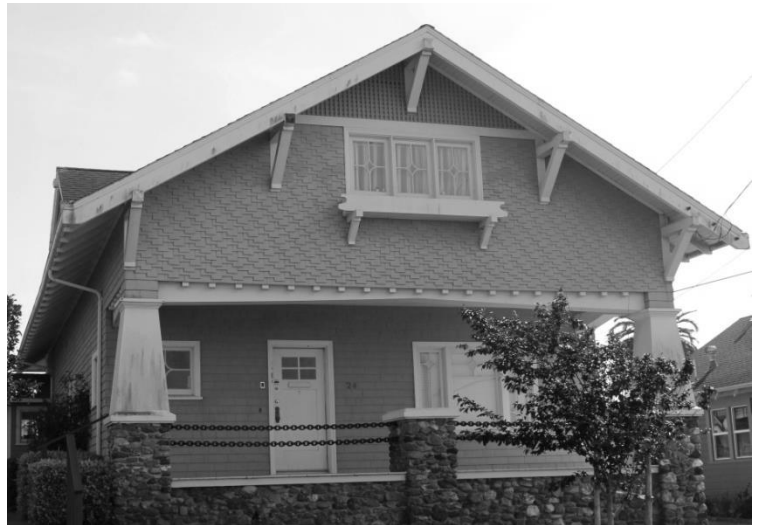
The Craftsman style appeared shortly after the turn of the century and was influenced by the work of Gustav Stickley and the Arts and Crafts movement. The Craftsman ideal toward simple, directly revealed craftsmanship was the result of a number of early 20th century tendencies, such as the rise of the middle class, the increase in individual home ownership, and a growing interest in nature and “natural living.” Characteristics of the style include:

- The use of local natural materials
- Wide overhanging eaves with exposed rafter tails
- Horizontal emphasis
- An open floor plan with connection to nature through the many windows and porches

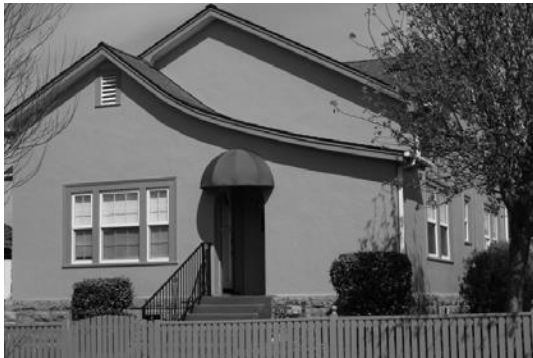
Norman Revival

By the 1920's, several styles based on earlier prototypes became popular. Often referred to as the 20th Century Period Revival, they include Colonial, Cape Cod, Spanish Colonial, Mediterranean, California Mission, Italian Renaissance, Norman Farmhouse, English Cottage, Moderne, and Tudor styles. Most houses built in these styles were smaller and less architecturally sophisticated than their ancestors. They were, in large part, popularized through catalogues and mail order companies. Although the majority of these houses were constructed in the 1920's, their use continued through the 1930's and 1940's

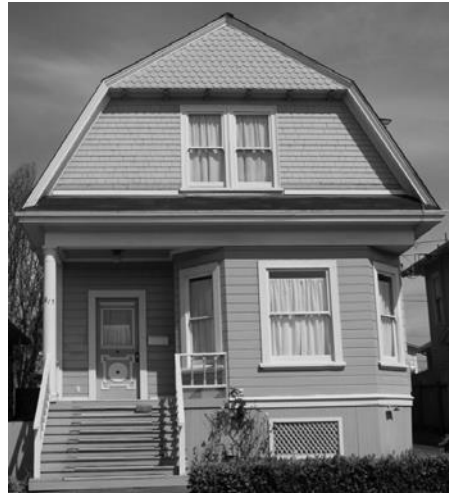
Dutch Colonial Revival

A variant of this style was the Dutch Colonial Revival, characterized by a gambrel roof form.

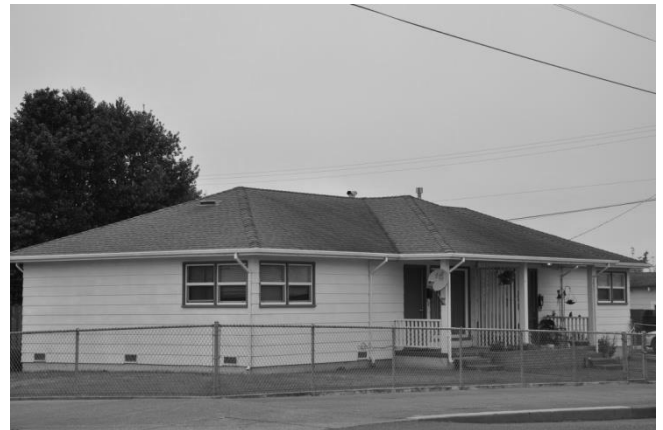
By the mid-1940's, the Ranch house was growing in popularity. Generally, the style is exemplified by:

- A single story
- Ground hugging profile
- A low pitched gable or hipped roof
- Wide overhanging eaves.
- Large windows often grouped to create a "window wall"
- Open floor plans
- A family room
- An attached garage
- Anonymous street façade
- Patios, courtyards and gardens are placed to the rear of the house
- Wood frame or masonry construction , with sheathing of horizontal wood siding, wood shingles, brick, stone, stucco, or a combination
